## Investigation report

**Investigation report No. 19/1706.1**

| Order description: | Proof of flammability to classify building materials to class B1<br>„schwerentflammbar“ according to DIN 4102, part 1 |
| Test samples: | TT Mediatex Vento |

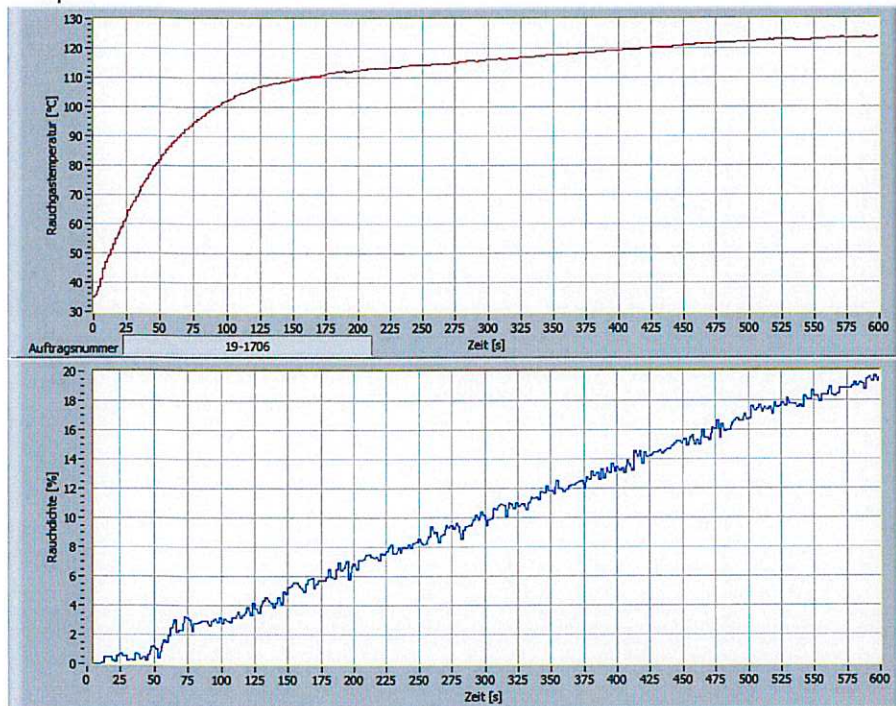
Sample: A

fig 1: Graphs of the flue gas temperature and the smoke density

| | | Result with the tested specimen | | | | | |
|---|---|---|---|---|---|---|--|
| 28 | <b>Density of smoke</b> | | 95,35 | 96,46 | 101,45 | | |
| 34 | Maximum of average value | °C | 123,8 | 130,3 | 132,5 | | |
| 35 | Time <sup>1)</sup> | min:s | 10:00 | 9:58 | 9:59 | | |

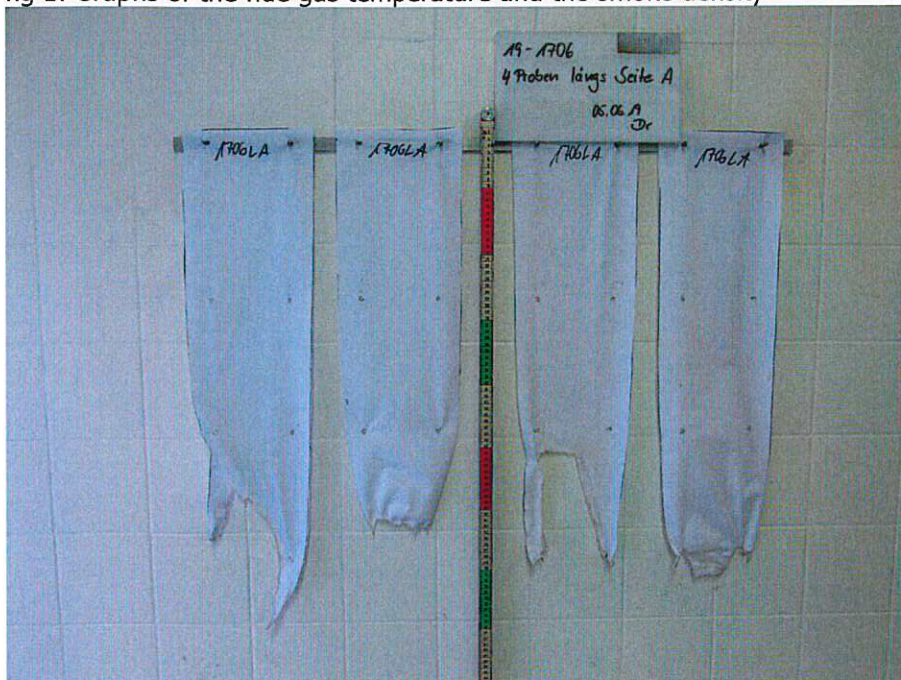
fig 2: Photo of test specimen after the test

| | | Result with the tested specimen | | | | | |
|---|---|---|---|---|---|---|--|
| 31 | Individual value <sup>3)</sup> | cm | 55 60<br>50 67 | 54 55<br>47 62 | 58 63<br>49 64 | | |
| 32 | Average value, individual test <sup>3)</sup> | cm | 58 | 55 | 59 | | |

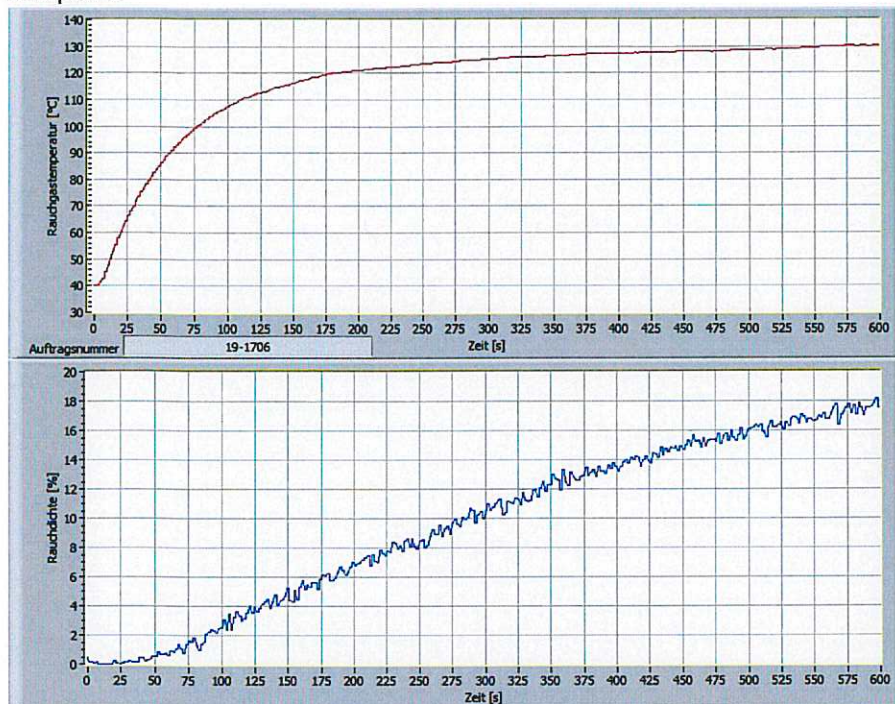
Sample: B

fig 1: Graphs of the flue gas temperature and the smoke density

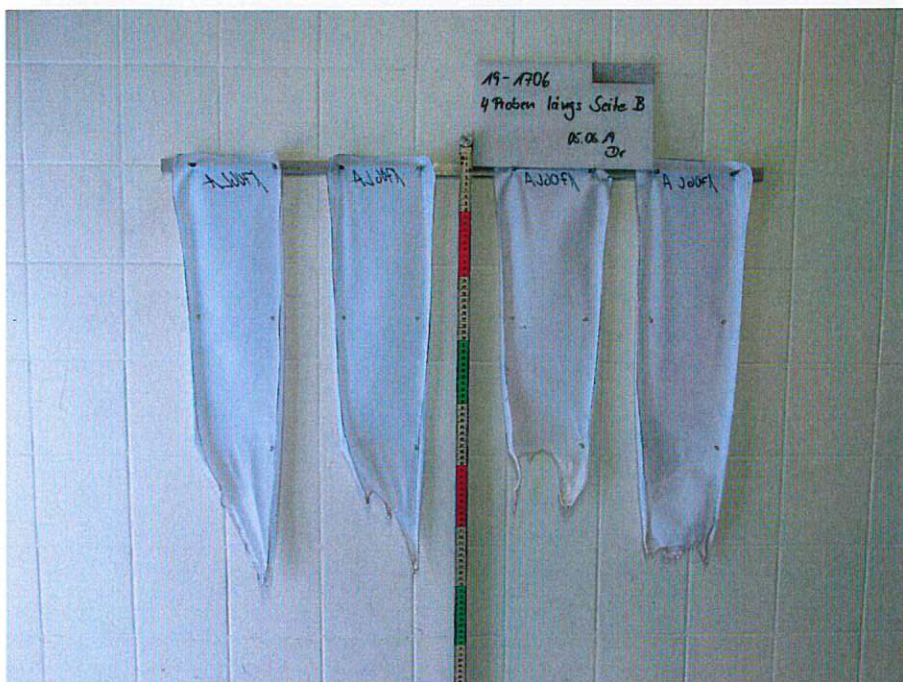
fig 2: Photo of test specimen after the test

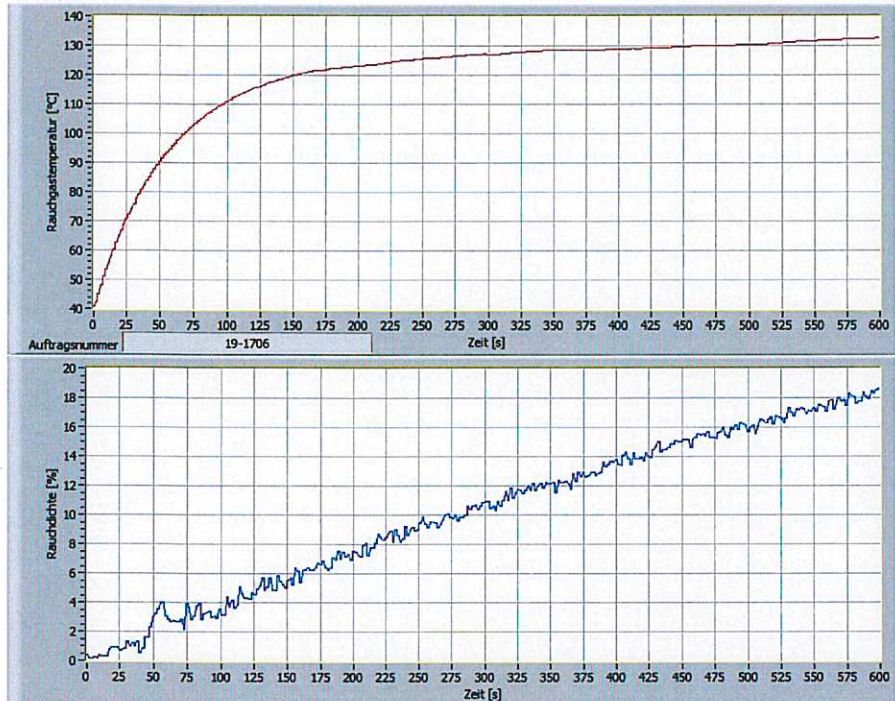
Sample: C

fig 1: Graphs of the flue gas temperature and the smoke density

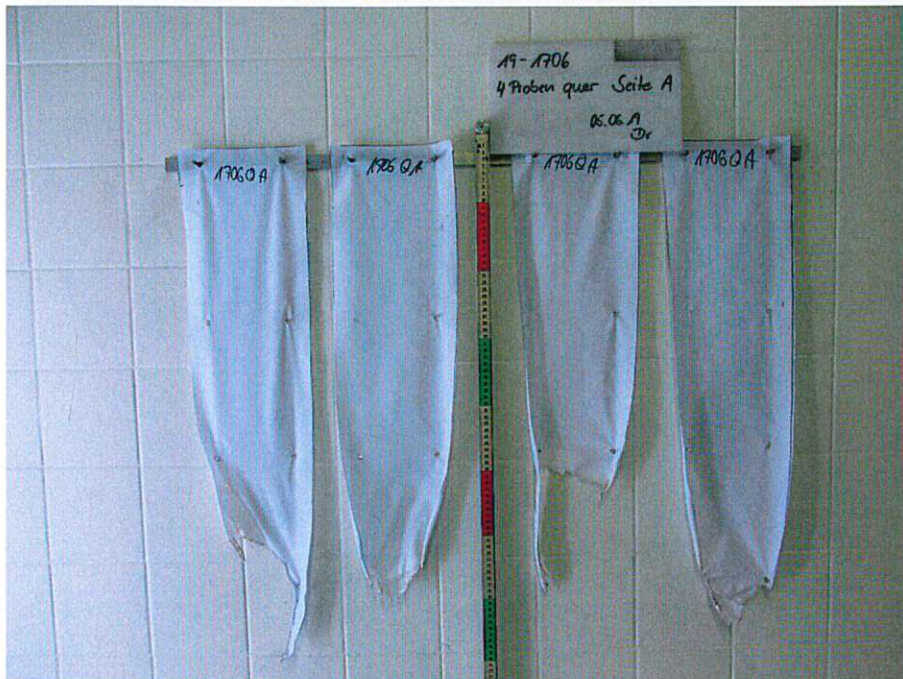
fig 2: Photo of test specimen after the test
